**CRA SHWORTHINESS OF AIRCREW PROTECTIVE ARMOR**

**Aviation Safety Engineering and Research  
Phoenix, Arizona**

TECHNICAL REPORT  
68-57-CM

April 1968

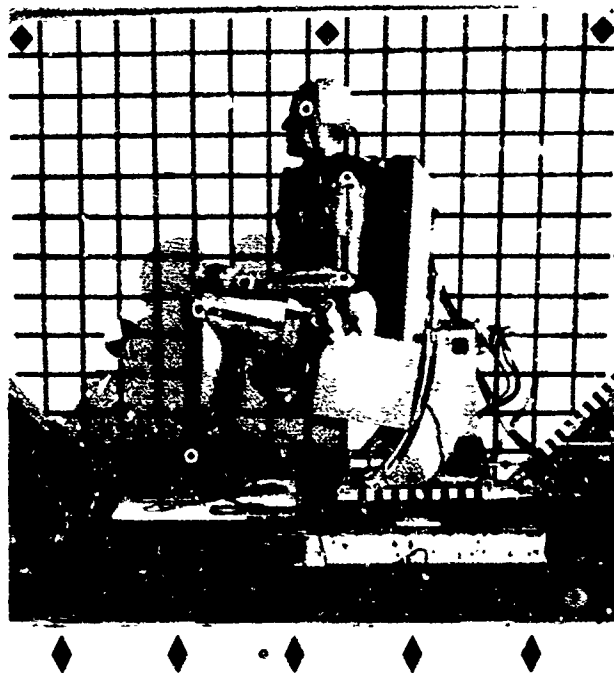
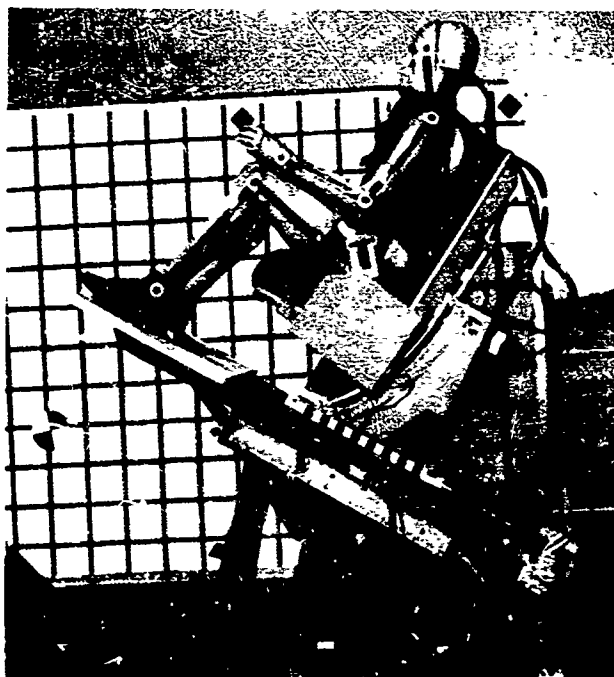
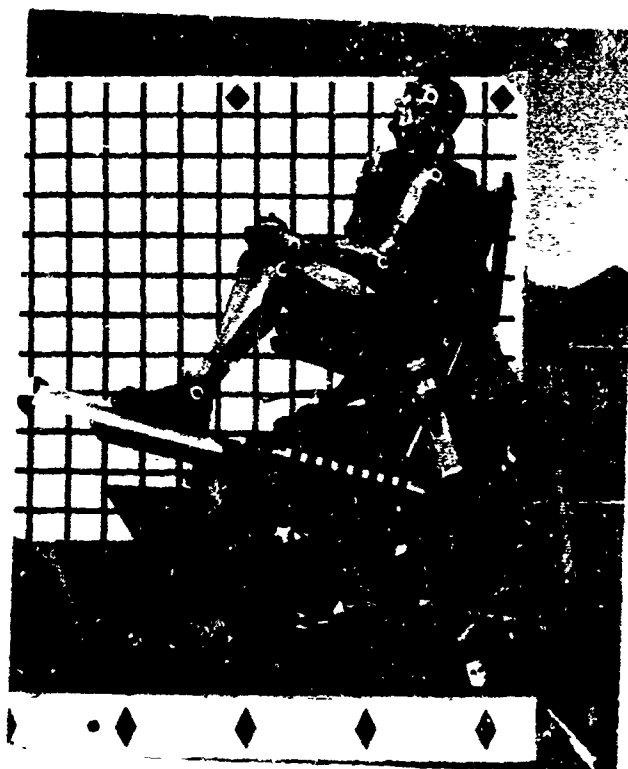
Three seat orientations were used during this series of tests: longitudinal with zero pitch and zero yaw, longitudinal with 30-degree pitch and zero yaw, and longitudinal with 15-degree pitch and 15-degree left yaw. Figures 49 through 51 show these orientations.

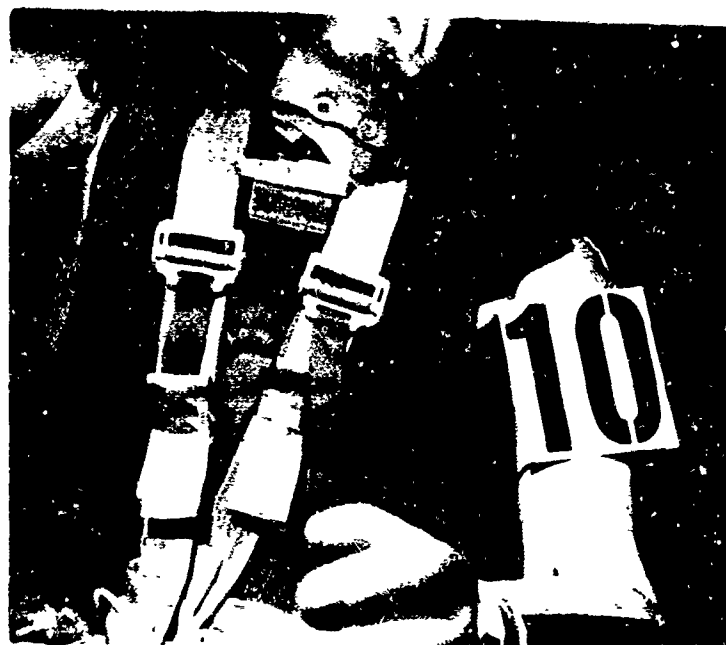
Figure 54. Chin Pad Installation.

Estimates of the loads applied to the thighs and chin of the occupant were obtained from crushable foam pads installed on the dummy and on the top of the armor. These pads were made of a material having a known crushing strength which remained approximately constant throughout the range of loads experienced. Figure 54 shows a typical chin installation after crushing by the chin impacting on the top of the armor. Figure 55 shows a posttest view of the thigh pad installation.

The chin pads showed varying degrees of crushing. The estimated impact loads imposed by the armor on the chin are given in Table II, column 9, with footnotes to indicate location of the impact. In general, the loads were more severe when the seats remained in place, or when the restraint harness was slack.

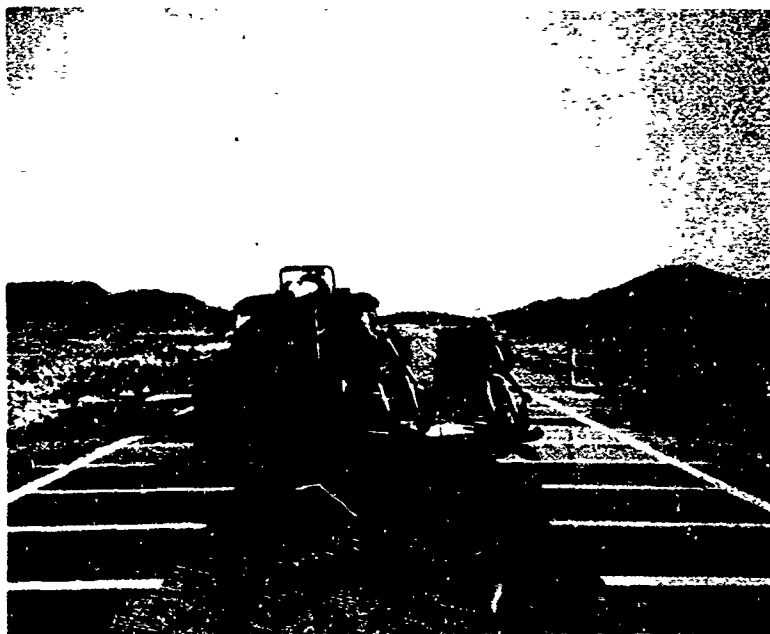
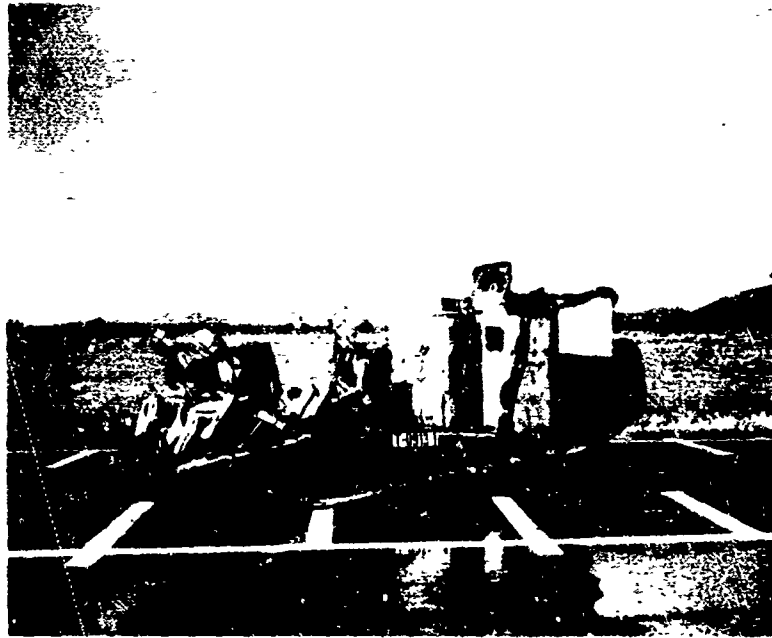
Figures 68 through 70 show the positions of all dummies after impact.

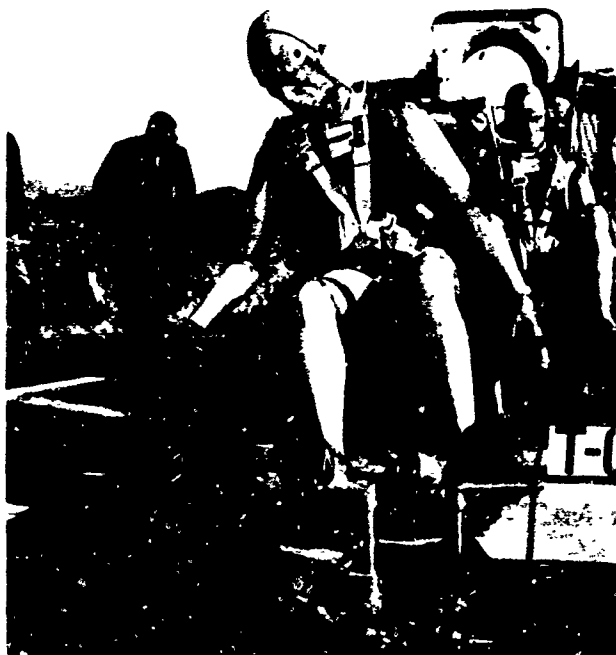
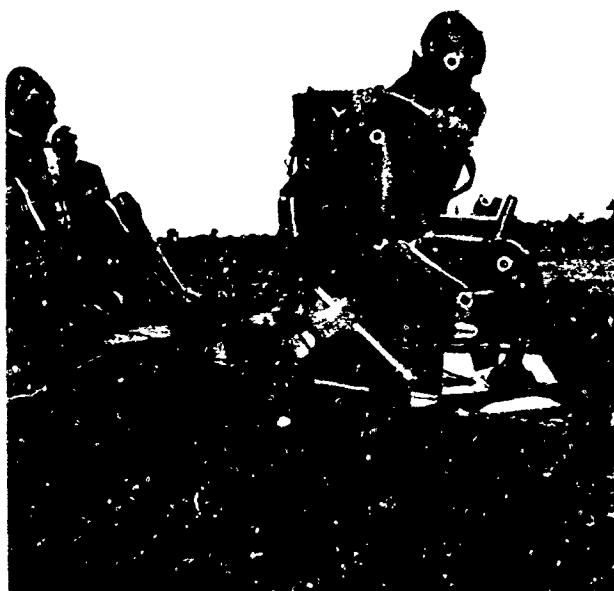
As previously mentioned, this seat was actually a copilot's seat, but was placed in this position so that the side armor would be inboard to avoid interfering with photographic coverage. The seat bucket stroked 5 inches vertically due to failure of the positioning pins in the seat height adjustment tubes. A partial failure of the weld on the support bracket for the side armor allowed the armor to deflect downward. Indentations in the foam thigh pads indicated that the chest armor impacted the right thigh with a force of 500 pounds. No appreciable crushing was found in either the left thigh pad or the chin pad. Analysis of the high-speed film indicates that the chin did not strike the armor. Figures 71 and 72 show front and side views of the final position of seat and dummy. Notice the extremely high position of the lap belt buckle. This is a result of the slack induced by the vertical movement of the bucket.

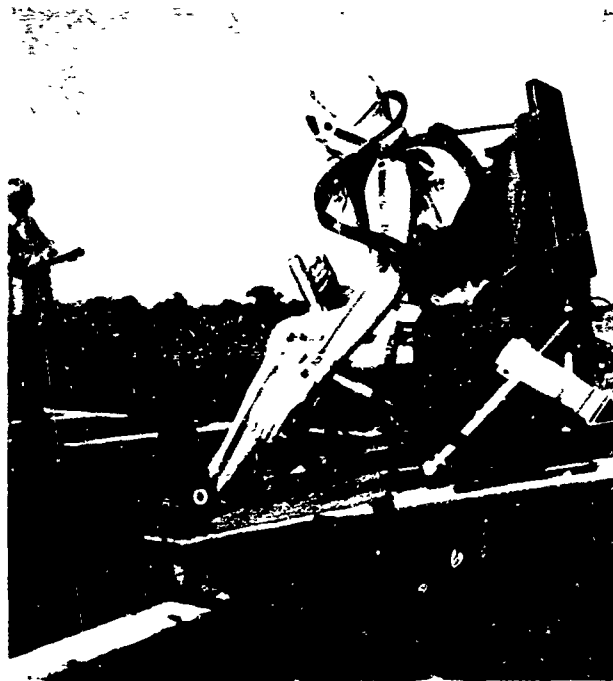
Figure 74. Postcrash Side View - Copilot Position.

Figures 73 and 74 show the final position of this seat and dummy. Notice again the extremely high position of the lap belt buckle caused by slack that was induced by the vertical displacement of the seat bucket.

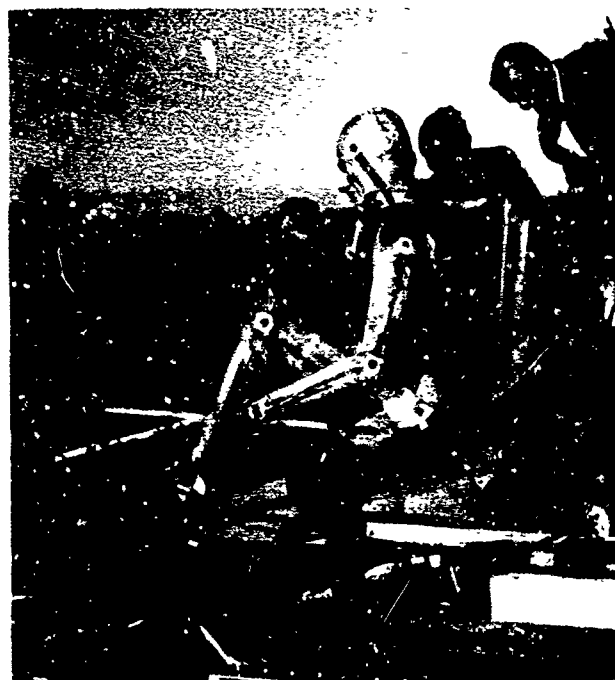
Figure 76. Postcrash Side View - CH-47 Seat.

This seat also displaced vertically due to failure of the height adjusting mechanism. The seat bottomed severely on the seat mount; however, no crushing was observed in the thigh pads or chin pad. This would indicate that the armor did not strike the thighs or chin with any appreciable force. Figures 75 and 76 show the final position of this seat and dummy. Note that the lap belt has remained in place. No slack was introduced by the vertical displacement since the belt is fastened to the seat.

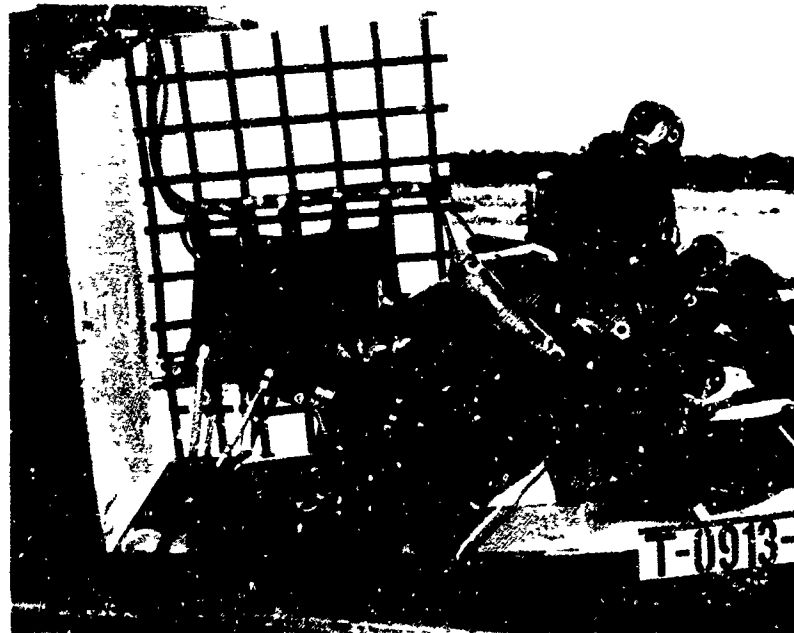
Figure 78. Postcrash Front View UH-1 Troop Seat.

The pad on the right thigh showed an indentation produced by a load of 370 pounds. However, this is believed to have been caused by the upper edge of the thigh armor as the dummy jackknifed. The final position of this armor can be seen in Figure 78. The chin impacted the top of the armor with a force calculated at 40 pounds. As the dummy moved down and forward, the armor rebounded and moved up the torso until it was restrained by the lower portion of the arm opening in the carrier vest (Figure 77). The snaps on the shoulder straps connecting the front and rear carriers pulled loose on the right shoulder. There was no damage in this separation - the snaps simply separated in their normal manner.
